## Long-Term Development of Planted Mangrove Wetlands in Florida

by Deborah Shafer and Thomas Roberts

**PURPOSE:** This technical note documents long-term trends in stand development for mangrove mitigation sites in southern and central Florida, and compares structural characteristics of planted and natural mangrove sites.

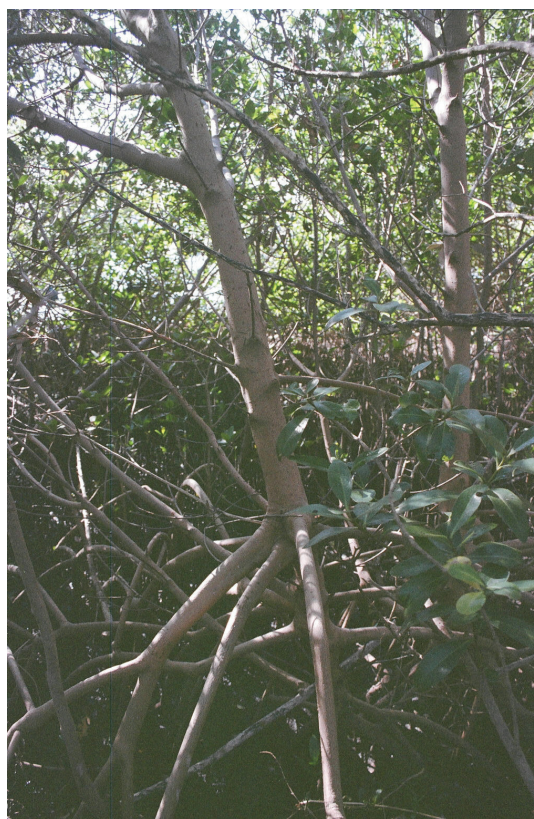
Figure 2. Red mangrove.

**METHODS:** In Florida, three mangrove species occur: the red mangrove (*Rhizophora mangle*) (Figure 2), black mangrove (*Avicennia germinans*), and the white mangrove (*Laguncularia racemosa*) (Odum et al. 1982). Red mangroves typically occupy the lower elevation zones at the edges of bays, tidal creeks, and rivers, while black and white mangroves occupy the higher elevation zones (Lewis 2005). Mangrove zonation patterns have been described by numerous authors, and appear to be the result of both chemical and physical factors such as salinity and hydroperiod, as well as interspecific competition (Odum et al. 1982).

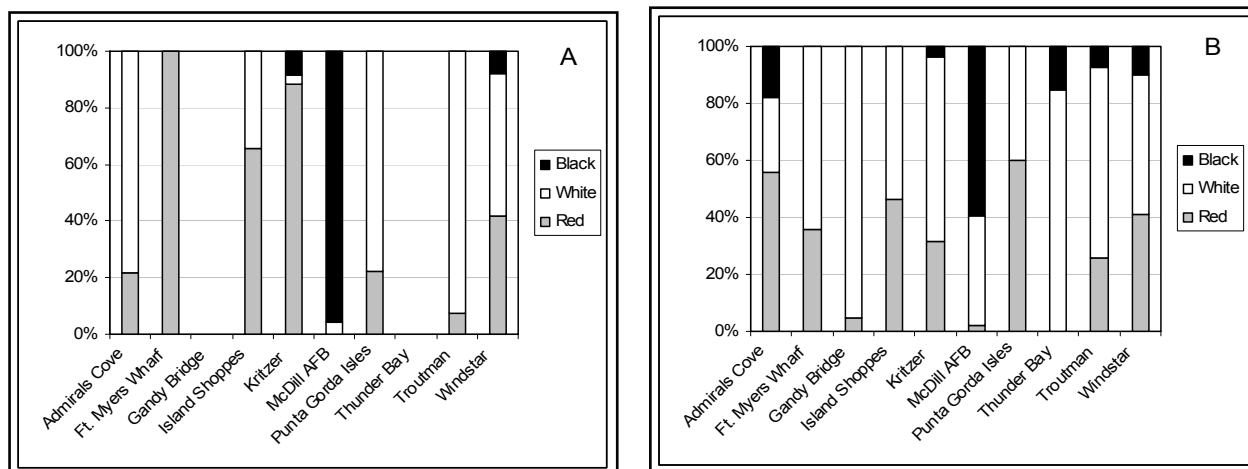
By 2005, white mangrove had become the dominant species at a majority of the sites, including two sites that had lacked mangroves in 1988, and one site that was formerly 100 percent red mangrove (Figure 3B). Black mangrove was present at only six sites, where it generally represented less than 20 percent of the mangrove community (Figure 3B). Mangrove species richness increased in 50 percent of the eight sites that had contained mangroves in 1988. By 2005, all three mangrove species were present at five sites (Figure 3B).

Figure 3. Species composition of planted mangrove sites in 1988 (A) and 2005 (B).

**Species composition:** In most cases, the species composition of the original planting was unknown. However, species composition at a majority of the sites changed considerably during the interval between sampling periods. In their early development stages, most sites were dominated by a single mangrove species (Figure 3A). In 1988, three sites were dominated by red mangrove, Fort Myers Wharf (100 percent), Island Shoppes (66 percent), and Kritzer (88 percent) (Figure 3A). The MacDill AFB site was predominantly (> 95 percent) black mangrove; black mangrove was present at only two other sites in 1988, where it represented a very small proportion (<10 percent) of the mangrove community (Figure 3A). The Admiral’s Cove, Punta Gorda Isles, and Troutman sites were predominantly (>75 percent) white mangrove (Figure 3A). Two sites, Gandy Bridge and Thunder Bay, lacked mangroves. Only two sites, Kritzer and Windstar, contained all three mangrove species at the time of sampling in 1988 (Figure 3A). Since these two sites were already five years old in 1988, it is possible that this diversity was due to volunteer recruitment by mangrove seeds or seedlings.

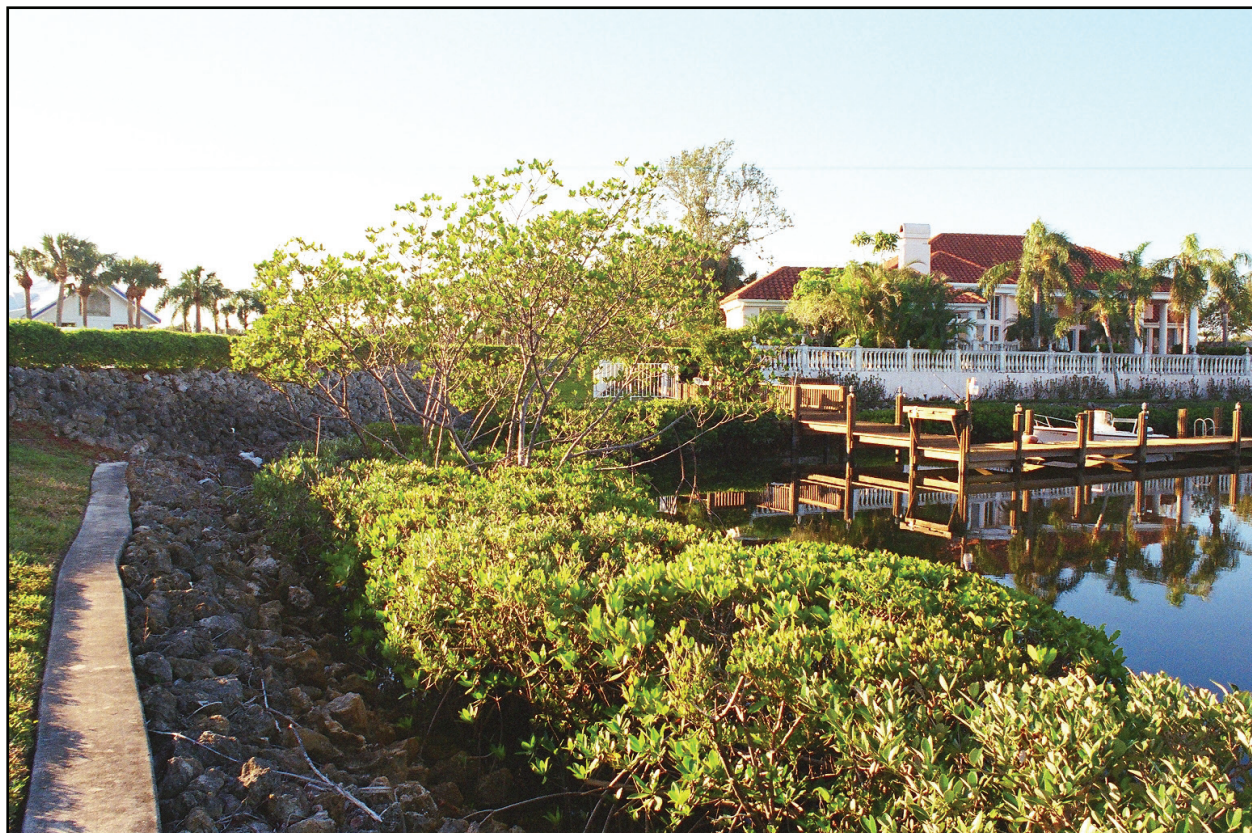
**Canopy height.** Mean height increased during the interval between sampling periods at all except one of the sites. This site was one in which the planted mangroves are routinely trimmed to maintain a view of the canal system (Figure 4). Excluding this site, the rate of increase in canopy height from 1988 to 2005 ranged between 5.4 and 25 cm/year, with an average of 16.4 cm/year (Table 3). The most rapid rate of increase in canopy height (25.0 cm/yr) was observed at the Island Shoppes site. The fact that these trees were planted in an existing wetland that had been cleared rather than in an excavated site may have been responsible in part for the high rate of growth at this site. The rate of growth at one site (Kritzer) was very slow in comparison with other sites (Table 3). This site, in an area of scrub mangroves located on Key Largo, differed from the others in that the substrate was composed largely of calcareous marl. Based on the 95-percent confidence intervals for canopy height constructed from the paired *t*-test analysis (excluding both the trimmed and scrub sites), the estimated rate of increase in canopy height for planted mangrove wetlands in Florida during the first two decades of site development can be predicted to range from 13-23 cm/year.

Figure 4. Trimmed mangrove fringe in Admiral's Cove.

where wetland presence conflicted with intended property uses resulted in the wetlands either being destroyed or dramatically altered. The Peace River site adjacent to Interstate Highway 75 had apparently been mowed or sprayed with herbicide (presumably by the highway department), whereas the Admiral's Cove site mentioned previously had been trimmed to maintain a view. Mangrove trimming is regulated by the 1996 Mangrove Trimming and Preservation Act in sections 403.9321-403.9334 of the Florida Statutes. In general, mangroves may not be trimmed to a height less than 2 m; however, there are exemptions, including maintenance trimming of a previously authorized configuration. Activities such as these obviously prevent mitigation sites from obtaining the structural complexity they otherwise would. Reducing vertical complexity likely has adverse effects on birds that might use the mangroves for roosting as well as reducing the amount of organic material exported to the adjacent water body. The likelihood that such degradation might occur should be considered by regulatory agencies prior to issuance of permits.

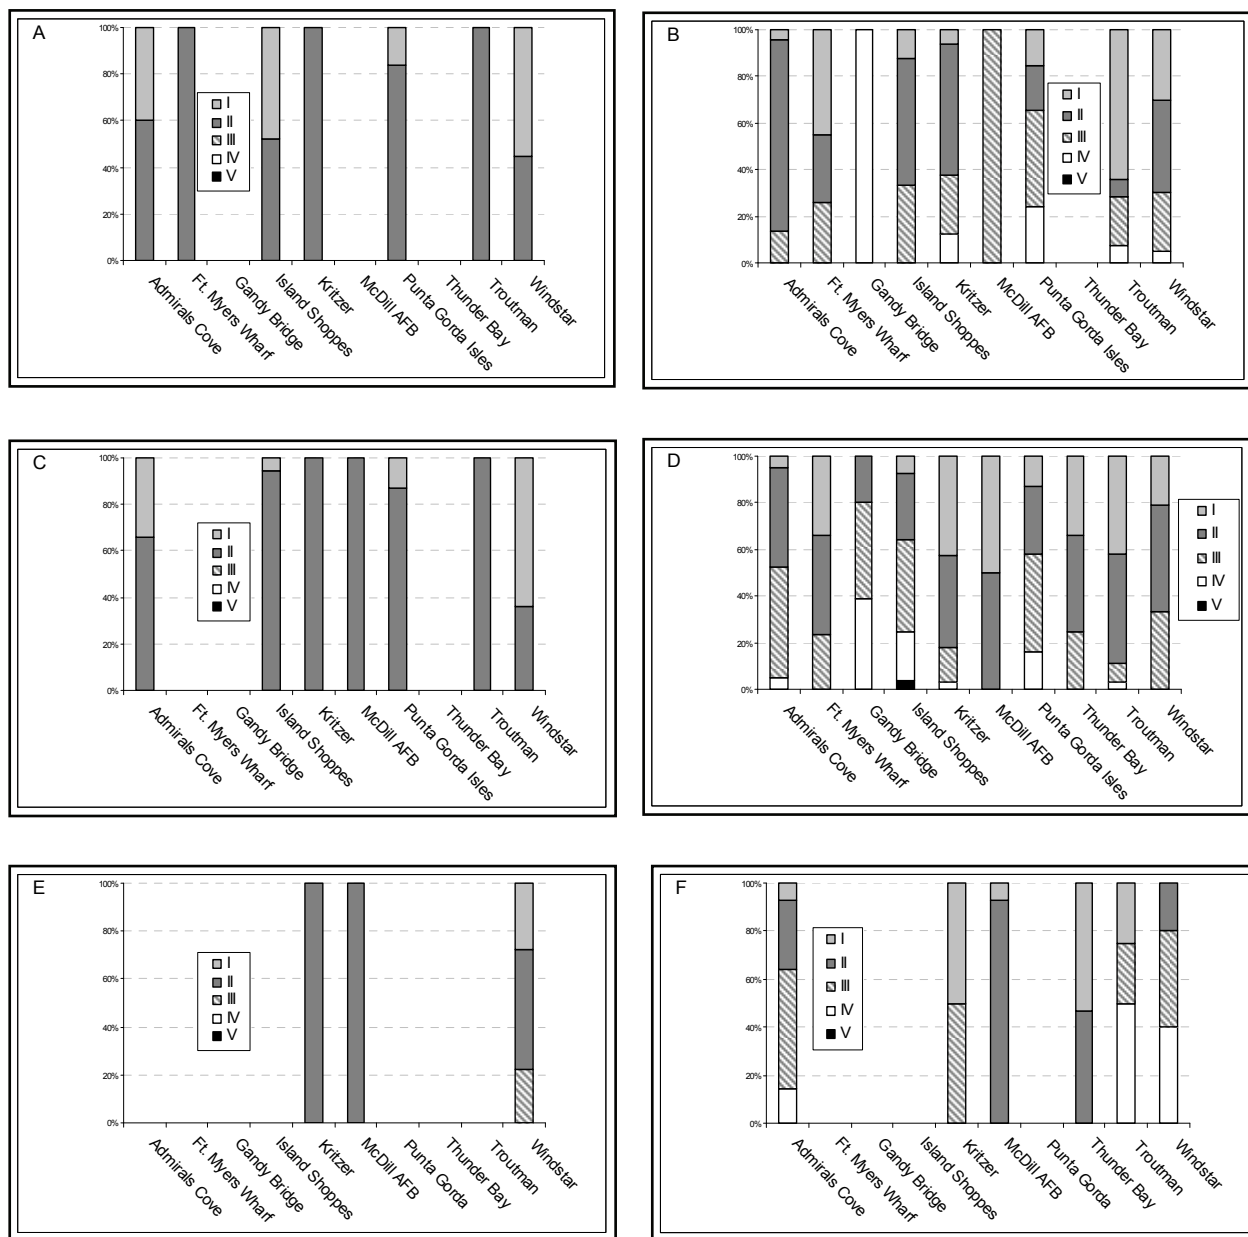
**Size class distribution.** With the exception of the Windstar site, all sites contained only small trees in size classes I and II ( $< 2.5$  cm DBH) when first sampled in 1988 (Figures 6A, 6C, and 6E). Only one site, Island Shoppes, contained large trees in size class V ( $> 10.2$  cm DBH) in 2005. Individuals in size class I were present at all sites in 2005 due to volunteer recruitment. White mangrove had colonized all nine sites, including two sites that had not contained white mangroves in 1988 (Figures 6C and 6D). Red mangrove recruitment was observed at all sites except Lookout Point and MacDill AFB (Figure 6B). Forty to fifty percent of the sites contained red and white mangroves in

size classes I through IV (Figures 6B and 6D), indicating continuous and ongoing recruitment of these species. Colonization by black mangroves was less frequent; of the seven sites not containing any black mangroves in 1988, only three sites subsequently became colonized by that species (Figures 6E and 6F). Only one site contained black mangroves in size classes I through IV, indicating less frequent and more episodic volunteer recruitment patterns by this species. Black mangrove seedlings also were observed less frequently than other species in 2005 (Figure 6F).

Figure 5. Percent composition by size class for each mangrove species. Red mangroves, 1988 (A) and 2005 (B); white mangroves, 1988 (C) and 2005 (D), and black mangroves, 1988 (E) and 2005 (F).

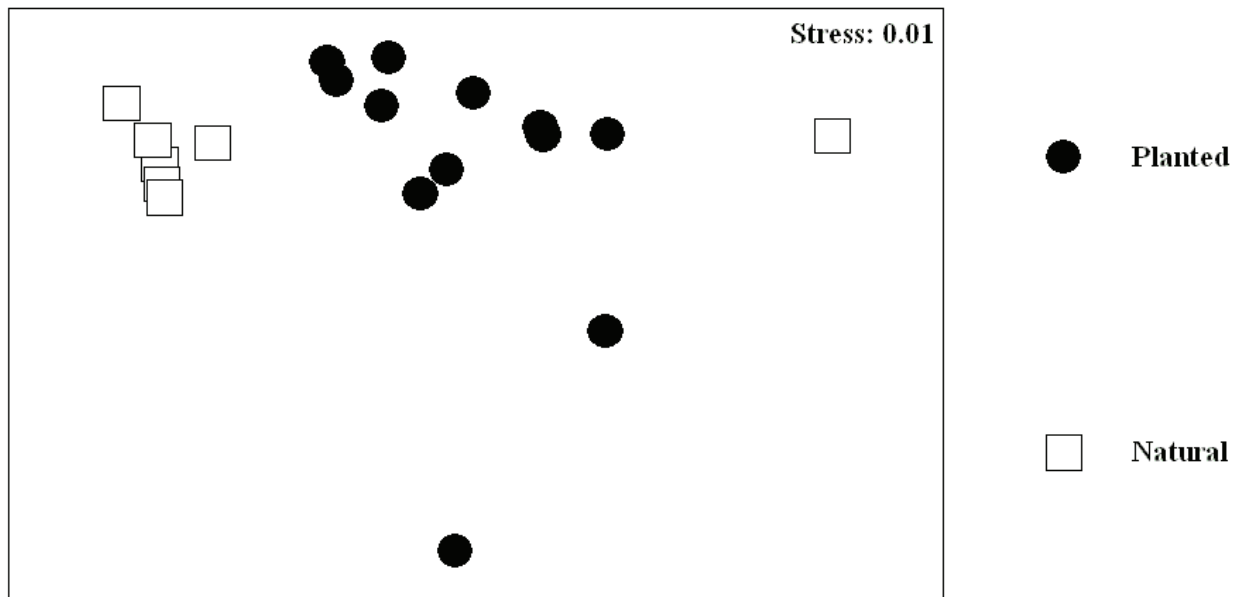
**Comparison with other Florida Mangrove Wetlands.** Structural complexity indices ( $I_c$ ) of planted mangrove wetlands were more variable than those of natural mangrove wetlands, ranging from less than 0.01 to 27.8, with an average of 5.3 (Table 4).  $I_c$  values for natural mangrove wetlands ranged from 0.2 to 5.0, with an average of 2.1 (Table 4). The MDS plot (stress = 0.01) indicated that despite some obvious similarities, structural characteristics (e.g. number of mangrove species, mean basal area, mean stem density, and mean canopy height) of 13- to 25-year-old planted sites differed from natural mangrove wetlands (Figure 3). Results of the ANOSIM analysis confirmed that stand structure of planted mangrove wetlands with volunteer recruitment over time was significantly different from natural sites ( $p = 0.01$ , Global  $R = 0.525$ ). Although the number of mangrove species was similar in both planted and natural sites, planted sites had lower basal area and height than natural sites, but were more dense and complex than natural sites (Table 4).

Figure 6. MDS plot of mangrove structural characteristics in planted and natural sites in Florida.
